FIRE RISK ASSESSMENT REPORT
on behalf of Colchester Borough Homes

308-314 Abbots Road
Colchester
CO2 8RL

Date assessed: 18th November 2022

Project Number: 86066

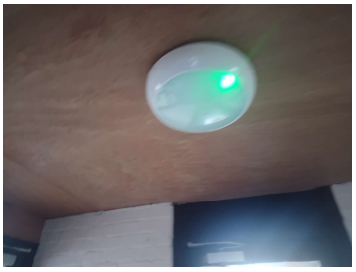
Hazard: Testing and Maintenance	Priority: Low
Issue Ref: ES/86066/006

Significant Findings: The assessor did not see any documented evidence within the premises to suggest that the emergency lighting is tested on a monthly basis, or to suggest that the emergency lighting has been serviced within the last twelve months. Please note failure to carry out testing and servicing can lead to faults with the system not been identified and is considered to be a deficiency of article 17 of the RR(FS)O 2005 – Maintenance.	
Action Required: Emergency lighting to be tested and maintained on a regular basis with results being recorded in logbook or central database.	
Actioned by:	**Date of Action:**
Comments Following Action:
