FIRE RISK ASSESSMENT REPORT
on behalf of Colchester Borough Homes

1-4 Affleck Road
Colchester
CO4 3XR

Date assessed: 20th March 2023

Project Number: 87004

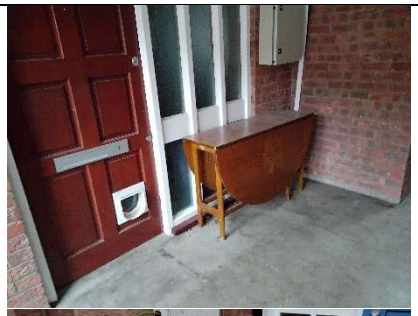
Hazard: Arson	**Priority: Medium**
Issue Ref: ES/87004/001	
Significant Findings: Combustible waste is being stored out front of building, and items stored in common area.	
Action Required: All combustible items should be stored within a secure storage area or bins.

Items in common area and front of building
