FIRE RISK ASSESSMENT REPORT
on behalf of Colchester Borough Homes

23-28 Affleck Road
Colchester
CO4 3XR

Date assessed: 20th March 2023

Project Number: 87007

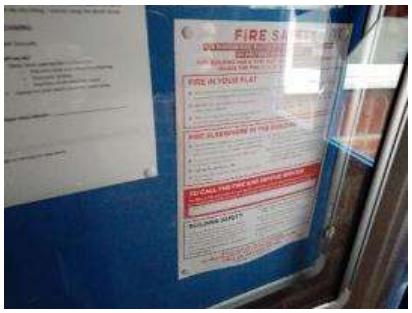
“No Smoking” signage not displayed on entry to the common areas.

Stay Put fire action notice
