FIRE RISK ASSESSMENT REPORT
on behalf of Colchester Borough Homes

43-48 Affleck Road
Colchester
CO4 3XR

Date assessed: 5th September 2022

Project Number: 85231

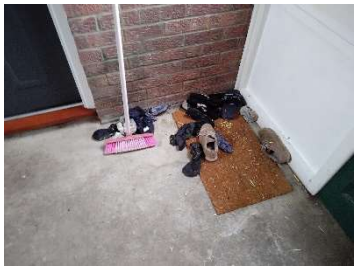
Hazard: Housekeeping	**Priority: Medium**
Issue Ref: ES/85231/005

Significant Findings: There were combustible items and trip hazards in the escape routes.	
Action Required: Management should contact residents to advise that the common area/escape routes should be kept free from all combustibles and/or trip hazards. A programme of regular checks should be put in place to ensure that the common area is kept clear.	
Actioned by:	**Date of Action:**
Comments Following Action:

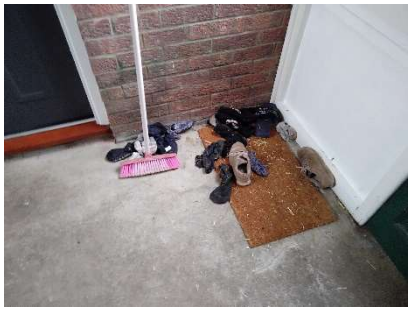
There were combustible items and trip hazards in the escape routes and in electrical cupboard.

Cleaning rota located on notice board.	
Items in common areas.
