FIRE RISK ASSESSMENT REPORT
on behalf of Colchester Borough Homes

1-11 Alport Avenue
Colchester
CO2 7XG

Project Number: 86071

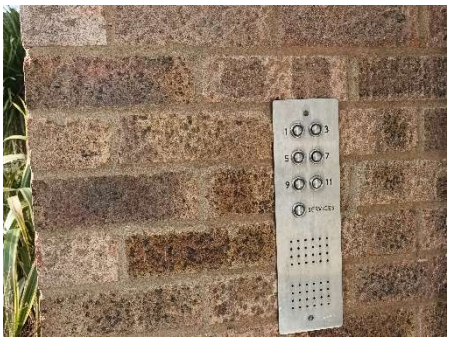
Electronic entry system.
