FIRE RISK ASSESSMENT REPORT
on behalf of Colchester Borough Homes

3-6 Ambrose Court
Colchester
CO6 1BT

Date assessed: 21st February 2023

Project Number: 86136

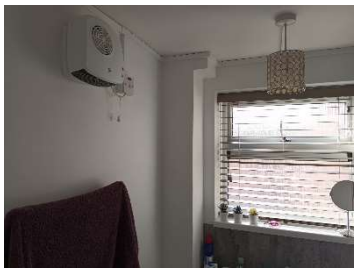
Hazard: Measures to Limit Fire Spread and Development	Priority: Medium
Issue Ref: ES/86136/004

Significant Findings: There appeared to be service riser pipes boxed in. The Consultant was unable to confirm if these pipes had been adequately fire stopped to prevent the spread of fire, smoke, and products of combustion in the event of a fire.	
Action Required: It is recommended that a survey is completed to ensure fire stopping has been completed to service risers to an adequate standard in all flats, any remedial works should be completed by a competent person and records provided and retained to verify these works.	
Actioned by:	**Date of Action:**
Comments Following Action:

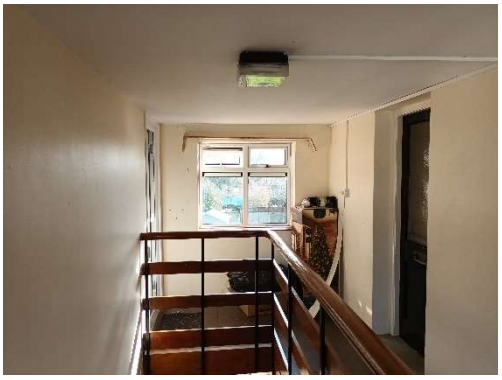
External waste facilities are located to the side of the premises which consists of wheelie bins. General housekeeping was in fair order throughout the premises. The only issue observed on the day of the assessment being rubbish bins stores and combustible items on the means of escape. See significant findings.

Combustible items on the means of escape.

Hazard: Measures to Limit Fire Spread and Development	Priority: Medium
Issue Ref: ES/86136/008	
Significant Findings: Combustible items were left on the first-floor landing on the means of escape. In the event of a fire these items could become a trip hazard prevent escape or they could provide fuel for a fire.	
Action Required: It is recommended that these combustible items are removed, and information is supplied to the residents on the hazards of storing items of the means of escape, that a system is set up to monitor these areas to prevent it occurring again.
