FIRE RISK ASSESSMENT REPORT
on behalf of Colchester Borough Homes

105-115 Artillery Street
Colchester
CO1 2JG

Date assessed: 24th February 2023

Project Number: 86185

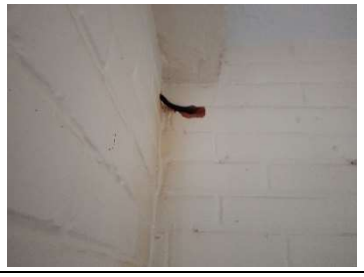
Hazard: Measures to Limit Fire Spread and Development	Priority: Medium
Issue Ref: ES/86185/007

Significant Findings: Compartmentation issues noted at the time of inspection include – Cable within the common area on first floor is breaching the wall to flat 109.	
Action Required: To prevent fire/smoke spread, the cable should be fire stopped by a competent contractor using suitable fire resisting materials that achieve a minimum of thirty minutes of fire resistance.	
Actioned by:	**Date of Action:**
Comments Following Action:
