FIRE RISK ASSESSMENT REPORT
on behalf of Colchester Borough Homes

10-19 Attlee Gardens
Colchester
CO1 2AQ

Date assessed: 2nd March 2023

Project Number: 87068

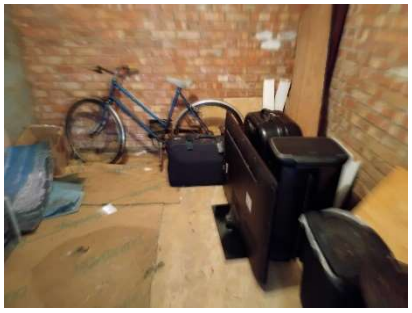
There were combustible items noted within the electrical intake cupboard at the time of inspection.

Items within electrical cupboard/room.

Hazard: Housekeeping	**Priority: Low**
Issue Ref: ES/87068/002	
Significant Findings: There were combustible items noted within the electrical intake cupboard at the time of inspection.	
Action Required: Management should contact residents to advise that the electrical cupboard/room should be kept free from all combustible hazards. A programme of regular checks should be put in place to ensure that the common area is kept clear.	
Actioned by:	**Date of Action:**
Comments Following Action:

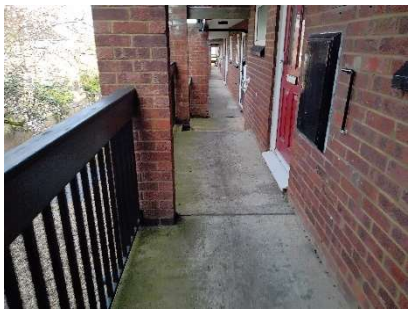
As the width of the access balconies or deck is less than 2m, it can be assumed that there is little risk of horizontal smoke spread along the balcony or deck from a fire in a flat, that would prevent residents from using the escape route. there are no additional fire hazards, such as stores or other ancillary rooms, located off the balcony or deck. Travel distances appear to be in line with that suggested in LGA - 'Fire safety in purpose-built blocks of flats' - 2012, section 5 – Escape from flats with external balcony or deck access approach.

External balcony.
