FIRE RISK ASSESSMENT REPORT
on behalf of Colchester Borough Homes

106-116 Avon Way
Colchester
CO4 3YJ

Date assessed: 6th March 2023

Project Number: 86180

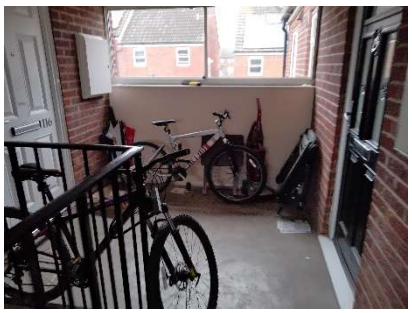
There were combustible items and trip hazards in the escape routes.

Refuse cupboard.	
Cleaning Rota.	
Items in common area.
