FIRE RISK ASSESSMENT REPORT
on behalf of Colchester Borough Homes

12-18 Avon Way
Colchester
CO4 3HN

Date assessed: 22nd March 2023

Project Number: 87012

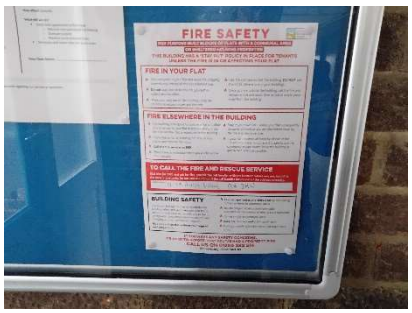
Hazard: Fire Safety Signs and Notices	**Priority: Low**
Issue Ref: ES/87012/006	
Significant Findings: No 'Keep Locked Shut' signage on entry doors.	
Action Required: In line with Safety Signs and Signals Regulations 1996 - PART 3 Fire safety signs**,** 'Keep Locked Shut' sign to be fitted to entry door.	
Actioned by:	**Date of Action:**
Comments Following Action:

No ‘Keep Locked Shut’ signage on entry doors.

Stay Put fire action notice.

Signage on electrical cupboard door.	
No signage on entry door.
