FIRE RISK ASSESSMENT REPORT
on behalf of Colchester Borough Homes

123-133 Avon Way
Colchester
CO4 3YJ

Date assessed: 6th March 2023

Project Number: 86181

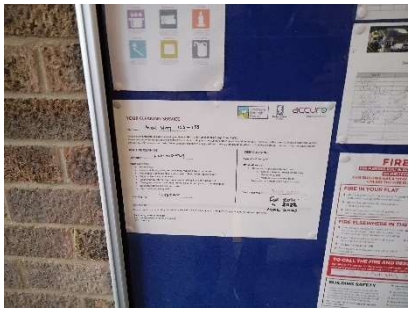
Housekeeping is of a good standard within the property and cleaning undertaken regularly, including rota displayed on notice board.

Refuse cupboard.	
Cleaning Rota.
