FIRE RISK ASSESSMENT REPORT
on behalf of Colchester Borough Homes

195-205 Avon Way
Colchester
CO4 3YS

Project Number: 86892

This report relates to the Fire Risk Assessment carried out at 195-205 Avon Way. The survey was conducted by Vincent Kain of Eurosafe UK on 6th March 2023 on behalf of Colchester Borough Homes.

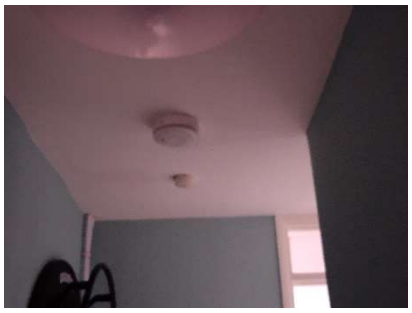
There is no communal automatic fire detection on the premises as per guidance outlined in Local Government Association - Fire Safety in Purpose Built Flats, Section 20.4: '. In 'general needs' blocks designed to support a 'stay put' policy, it is unnecessary and undesirable for a fire alarm system to be provided. A communal fire detection and alarm system will inevitably lead to a proliferation of false alarms. This will impose a burden on fire and rescue services and lead to residents ignoring warnings of genuine fires.' there was however, LD3 smoke detection within the hallway of the flats. This is taken from sampled flat 201.

Smoke detection.
