FIRE RISK ASSESSMENT REPORT
on behalf of Colchester Borough Homes

1-6 Azalea Court
Colchester
CO4 3NU

Date assessed: 21st March 2023

Project Number: 86951

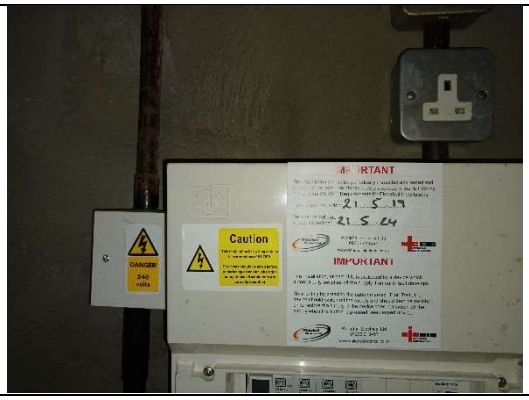
The site has an electrical system fed from the main distribution board in the electrical switch room for the communal areas. Whilst the Electrical wiring test was within date the responsible person should ensure the test certificate is satisfactory and any remedial actions completed.

Electrical wiring test.
