FIRE RISK ASSESSMENT REPORT
on behalf of Colchester Borough Homes

13-18 Azalea Court
Colchester
CO4 3NU

Project Number: 86950

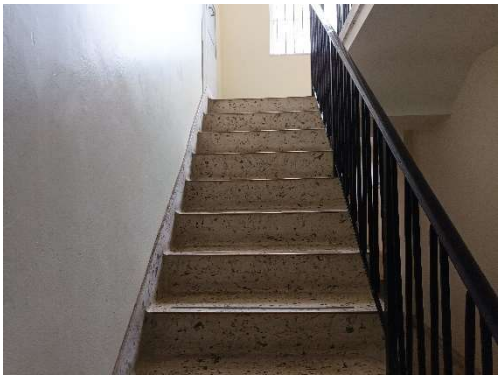
Means of escape kept sterile.
