FIRE RISK ASSESSMENT REPORT
on behalf of Colchester Borough Homes

7-12 Azalea Court
Colchester
CO4 3NU

Date assessed: 21st March 2023

Project Number: 86952

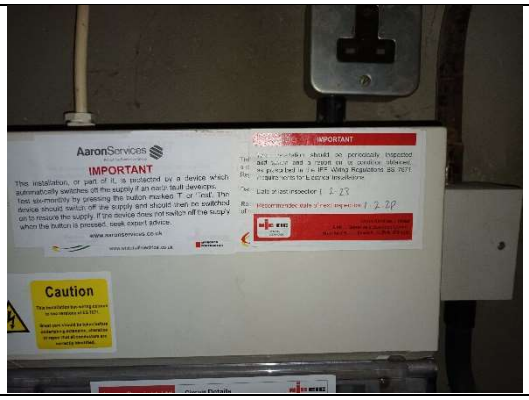
The site has an electrical system fed from the main distribution board in the electrical switch room for the communal areas. Whilst the Electrical wiring test was within date the responsible person should ensure the test certificate is satisfactory and any remedial actions completed.

Electrical wiring test.
