FIRE RISK ASSESSMENT REPORT
on behalf of Colchester Borough Homes

1-6 Bensusan Court
Colchester
CO2 9EF

Date assessed: 24th October 2022

Project Number: 85744

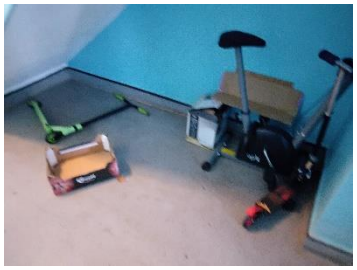
Hazard: Housekeeping	**Priority: Low**
Issue Ref: ES/85744/001

Significant Findings: There were combustible items noted under the stairs on the escape route at the time of inspection.	
Action Required: Management should contact residents to advise that the common area/escape routes should be kept free from all trip hazards. A programme of regular checks should be put in place to ensure that the common area is kept clear.	
Actioned by:	**Date of Action:**
Comments Following Action:

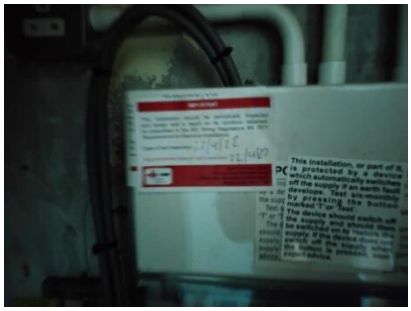
5 yearly fixed wire testing.

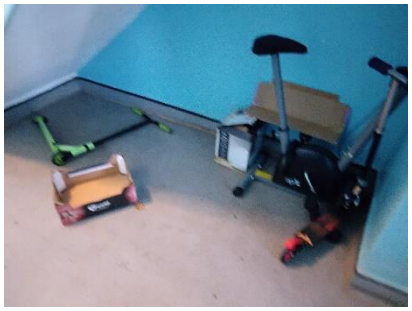
There were combustible items noted under the stairs on the escape route at the time of inspection.

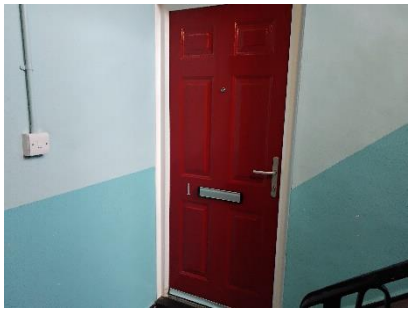
Cable leading to the storage cupboards located on ground floor is breaching the wall above all personal storage cupboards.	
Redundant cables within the electrical cupboard located on ground floor is breaching the wall.	
Example of flat entrance door.
