FIRE RISK ASSESSMENT REPORT
on behalf of Colchester Borough Homes

7-12 Bensusan Court,
Colchester,
CO2 9EF

Date assessed: 24th October 2022

Project Number: 85745

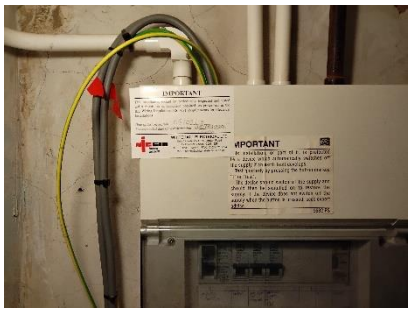
5 yearly fixed wire testing.

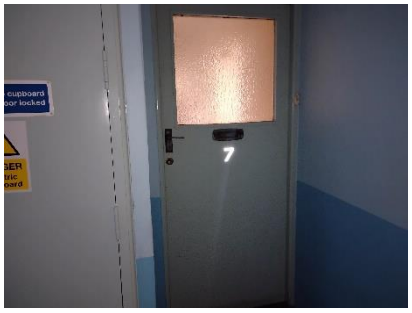
Access could not be gained to roof space. It is unknown whether there are breaches of compartmentation within the roof space.	
The assessor noted that there are no cold smoke seals or intumescent strips installed to the frame/door of the electrical riser cupboard.	
Personal storage cupboards located on ground floor have vents above the doors.

Cable leading to the storage cupboards located on ground floor is breaching the wall above all personal storage cupboards.	
Cable within the electrical cupboard located on ground floor is breaching the wall.	
Original flat 7 timber door.

Hazard: Measures to Limit Fire Spread and Development	**Priority: Medium**
Issue Ref: ES/85745/005	
Significant Findings: Compartmentation issues noted at the time of inspection include - Personal storage cupboards located on ground floor have vents above the doors.	
Action Required: To prevent fire/smoke spread, the vents above all cupboard doors should be fire stopped by a competent contractor using suitable fire resisting materials that achieve a minimum of thirty minutes of fire resistance.	
Actioned by:	**Date of Action:**
Comments Following Action:

Hazard: Measures to Limit Fire Spread and Development	**Priority: Medium**
Issue Ref: ES/85745/006	
Significant Findings: Compartmentation issues noted at the time of inspection include – Cable leading to the storage cupboards located on ground floor is breaching the wall above all personal storage cupboards.	
Action Required: To prevent fire/smoke spread, the cables above all cupboard doors should be fire stopped by a competent contractor using suitable fire resisting materials that achieve a minimum of thirty minutes of fire resistance.	
Actioned by:	**Date of Action:**
Comments Following Action:

Hazard: Measures to Limit Fire Spread and Development	**Priority: Medium**
Issue Ref: ES/85745/007	
Significant Findings: Compartmentation issues noted at the time of inspection include – cable within the electrical cupboard located on ground floor is breaching the wall.	
Action Required: To prevent fire/smoke spread, the cables above all cupboard doors should be fire stopped by a competent contractor using suitable fire resisting materials that achieve a minimum of thirty minutes of fire resistance.	
Actioned by:	**Date of Action:**
Comments Following Action:
