FIRE RISK ASSESSMENT REPORT
on behalf of Colchester Borough Homes

1-7 Berefield Way
Colchester
CO2 8PQ

Date assessed: 12th December 2022

Project Number: 86105

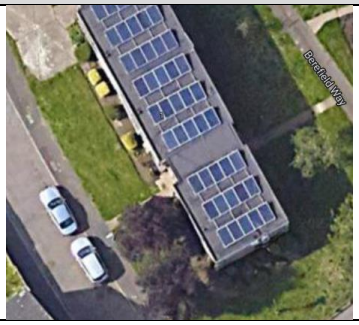
Hazard: Electrical Sources of Ignition	**Priority: Medium**
Issue Ref: ES/86105/001

Significant Findings: Photovoltaic system located on the roof of premises. There was no evidence of testing or servicing.	
Action Required: It is recommended that servicing and regular maintenance is undertaken in accordance with manufacturers guidance**.**	
Actioned by:	**Date of Action:**
Comments Following Action:
