FIRE RISK ASSESSMENT REPORT
on behalf of Colchester Borough Homes

14-20 Berefield Way
Colchester
CO2 8PQ

Date assessed: 12th December 2022

Project Number: 86104

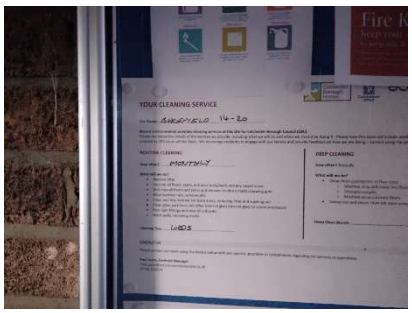
Cleaning rota displayed on notice board.

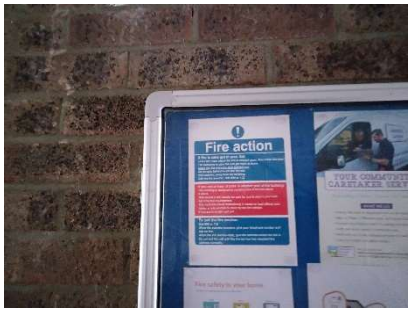
There is also ‘No smoking’ signage in common area.

No smoking signage displayed on entry to the common areas.	
Keep Locked Shut and Danger Electricity signage on electrical intake cupboard.	
The current evacuation strategy is Stay Put as denoted by the fire action notices displayed in the common area.
