# FIRE RISK ASSESSMENT REPORT
# on behalf of Colchester Borough Homes

# 4-7 Bob Russell House
# Colchester
# CO1 2EF

**Date assessed: 2nd March 2023**

**Project Number: 86206**

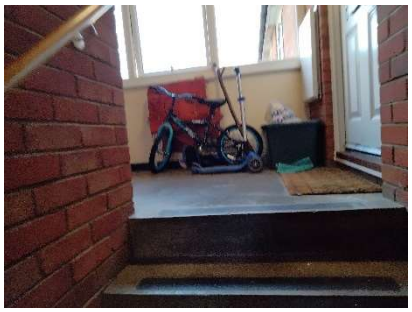
| **Hazard: Housekeeping** | **Priority: Low** |
|---|---|
| **Significant Findings:** There were combustible items and trip hazards in the escape routes. | |

| Combustible items in common area. | |

| **Hazard: Housekeeping** | **Priority: Low** |
|---|---|
| **Action Required:** Management should contact residents to advise that the common area/escape routes should be kept free from all combustibles and/or trip hazards. A programme of regular checks should be put in place to ensure that the common area is kept clear. | |
