FIRE RISK ASSESSMENT REPORT
on behalf of Colchester Borough Homes

40-43 Bradbrook Cottages
Colchester
CO6 3JW

Date assessed: 6th March 2023

Project Number: 86138

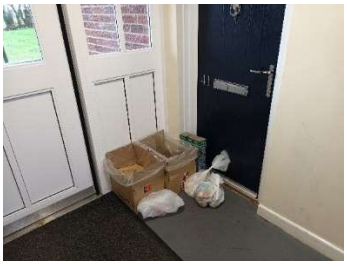
Hazard: Housekeeping	Priority: High
Issue Ref: ES/86138/007

Significant Findings: The Consultant advises that there is combustible rubbish outside flat 41 on the means of escape. In the event of a fire in the rubbish room smoke and fire may travel to the upper floors.	
Action Required: It is recommended that these combustible items are removed, and information is supplied to the residents on the hazards of storing items of the means of escape. A system should be set up to monitor these areas to prevent it occurring again. This is high risk as the storage is next to the escape door.	
Actioned by:	**Date of Action:**
Comments Following Action:
