FIRE RISK ASSESSMENT REPORT
on behalf of Colchester Borough Homes

1-4 Buckingham Drive
Colchester
CO4 3YH

Date assessed: 2nd March 2023

Project Number: 86895

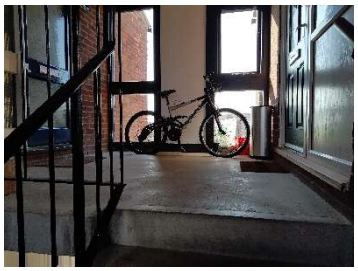
Significant Findings: There were combustible items and trip hazards in the escape routes.	
Action Required: Management should contact residents to advise that the common area/escape routes should be kept free from all combustibles and/or trip hazards. A programme of regular checks should be put in place to ensure that the common area is kept clear.

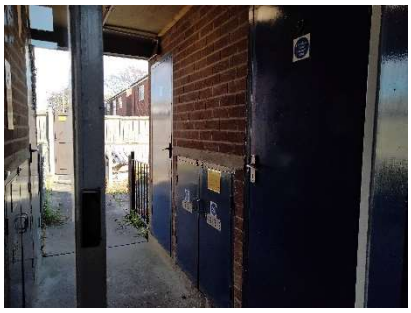
Refuse area.

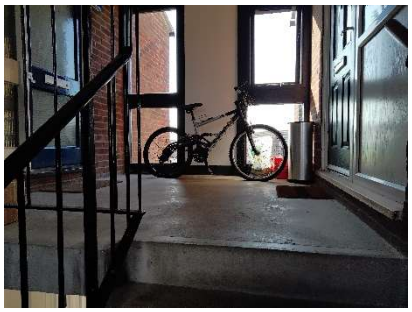
There were combustible items and trip hazards in the escape routes.

Items in common area.
