FIRE RISK ASSESSMENT REPORT
on behalf of Colchester Borough Homes

14a-16 Buckingham Drive
Colchester
CO4 3YH

Date assessed: 2nd March 2023

Project Number: 86896

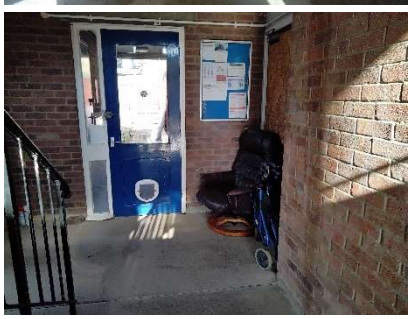
There were combustible items and trip hazards in the escape routes.

Cleaning Rota.	
Items in common area.

Hazard: Housekeeping	**Priority: Low**
Issue Ref: ES/86896/001	
Significant Findings: There were combustible items and trip hazards in the escape routes.	
Action Required: Management should contact residents to advise that the common area/escape routes should be kept free from all combustibles and/or trip hazards. A programme of regular checks should be put in place to ensure that the common area is kept clear.

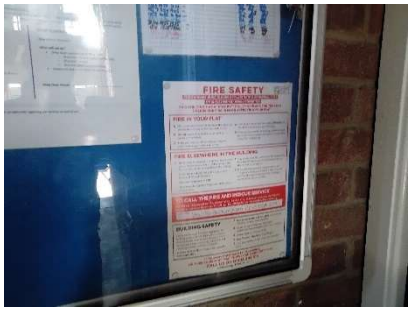
Stay Put fire action notice.

No signage on entry door.	
Signage on electrical cupboard door.

No smoking signage.

Hazard: Fire Safety Signs and Notices	Priority: Low
Issue Ref: ES/86896/007	
Significant Findings: No 'Keep Locked Shut' signage on doors including entry doors.	
Action Required: In line with Safety Signs and Signals Regulations 1996 - PART 3 Fire safety signs**,** 'Keep Locked Shut' sign to be fitted to entry door.	
Actioned by:	**Date of Action:**
Comments Following Action:
