FIRE RISK ASSESSMENT REPORT
on behalf of Colchester Borough Homes

23-26 Buckingham Drive
Colchester
CO4 3YH

Date assessed: 2nd March 2023

Project Number: 86898

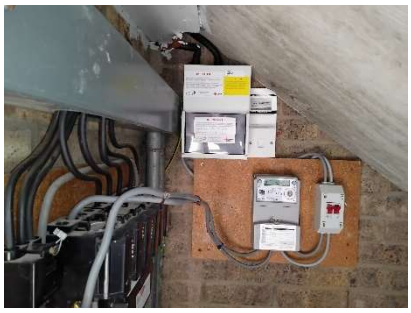
System test date label.

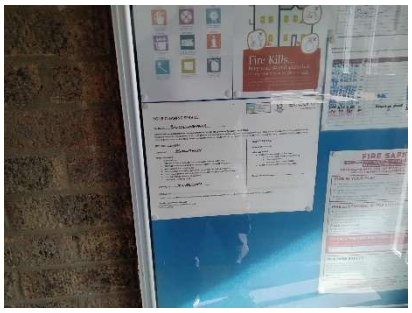
Cleaning Rota.

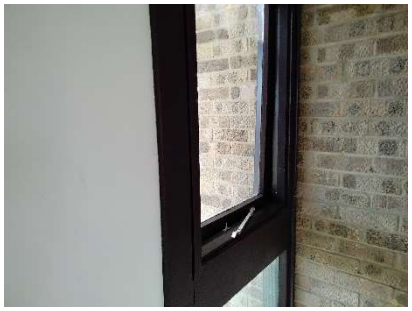
Openable window on first floor.

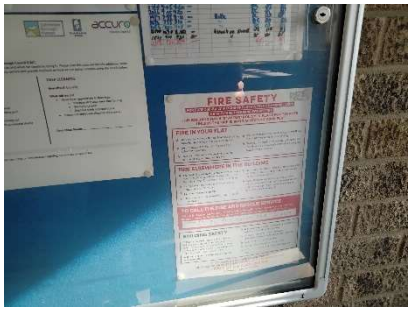
Stay Put fire action notice.
