FIRE RISK ASSESSMENT REPORT
on behalf of Colchester Borough Homes

9-12 Buckingham Drive
Colchester
CO4 3YH

Date assessed: 2nd March 2023

Project Number: 86899

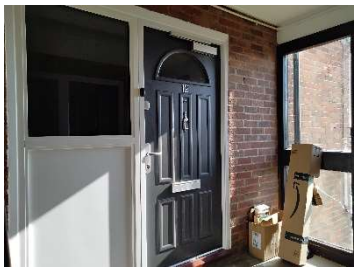
Hazard: Housekeeping	**Priority: Low**
Issue Ref: ES/86899/001

Significant Findings: There were combustible items and trip hazards in the escape routes.	
Action Required: Management should contact residents to advise that the common area/escape routes should be kept free from all combustibles and/or trip hazards. A programme of regular checks should be put in place to ensure that the common area is kept clear.	
Actioned by:	**Date of Action:**
Comments Following Action:

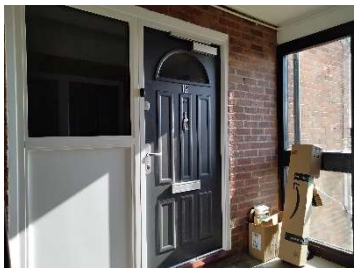
Hazard: Measures to Limit Fire Spread and Development	Priority: Medium
Issue Ref: ES/86899/004

Significant Findings: No entry was gained to flats during inspection.	
Action Required: As flat entrances have been fitted with composite door sets, these should have test evidence demonstrating they meet the performance requirement in Building Regulations guidance for fire resistance and smoke control from both sides. Management should confirm that suitable fire door test certificates are held and that these relate to the doors fitted. If adequacy cannot be confirmed it may be necessary for door sets to be replaced under a risk-based programme. In addition, an intrusive inspection should be carried out to confirm the adequacy of composite door set installations including the fixings and firestopping between the frame and the wall.	
Actioned by:	**Date of Action:**
Comments Following Action:

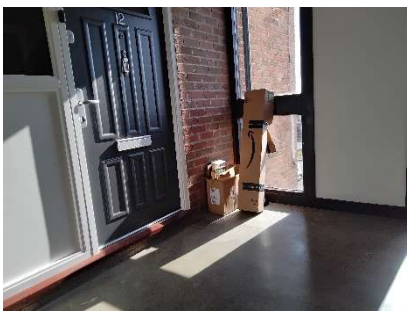
There were combustible items and trip hazards in the escape routes.

Refuse area.	
Cleaning Rota.	
Items in common area.

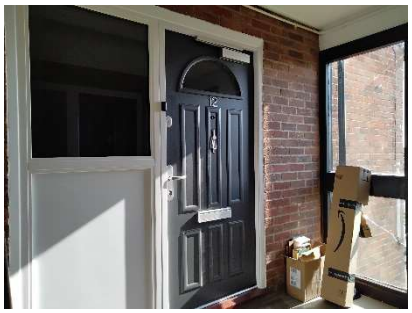
The assessor noted that there are no cold smoke seals or intumescent strips installed to the frame/door of the electrical riser cupboard.

Compartmentation issues noted at the time of inspection include – Cable within the electrical cupboard located on ground floor is breaching the frame leading to common area.

No seals on electrical cupboard.	
Example of flat door.

Cable breaching the electrical cupboard.	
External cladding.

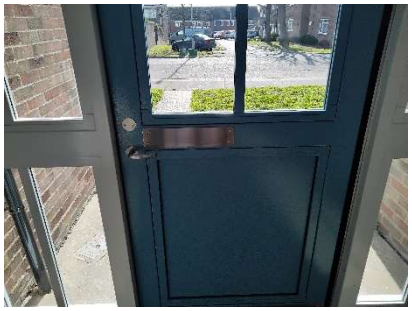
Stay Put fire action notice.	
No signage on entry door.

Signage on electrical cupboard door.

No smoking signage.
