FIRE RISK ASSESSMENT REPORT
on behalf of Colchester Borough Homes

7-12 Buffett Way
Colchester
CO4 3YL

Project Number: 86141

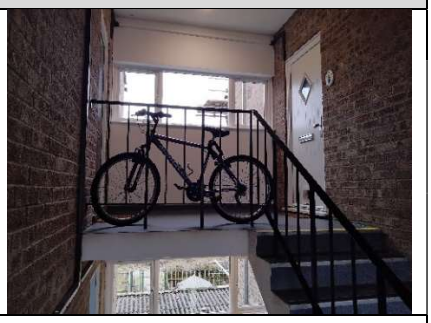
Hazard: Means of Escape	**Priority: Medium**
Issue Ref: ES/86141/003

Significant Findings: The Consultant advises a bicycle was being stored on the means of escape outside no.12 which could impede a residents escape in the event of a fire.	
Action Required: It is recommended that this bicycle be removed, and a system put in place to prevent the reoccurrence.	
Actioned by:	**Date of Action:**
Comments Following Action:

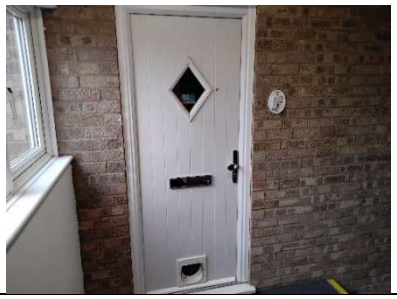
Hazard: Measures to Limit Fire Spread and Development	**Priority: Medium**
Issue Ref: ES/86141/004	
Significant Findings: The consultant advises that residents doors appeared to be fitted by the resident and appeared to be PVC. There was no evidence to show this was a FD30 door. The door has been altered with a cat flap installed as has no. 11 &12.	
Action Required: It is recommended that a fire door survey is completed, and any deficiencies noted are remedied. All Fire Door sets should be compliant/conform to BS 8214:2016 (Code of practice for Timber-based fire door assemblies) and BS 476-22:1987 or BS EN 1634-1:2014, maintained in a good state of repair, self-close fully, and be fitted with all necessary features (e.g., intumescent strips and cold smoke seals.

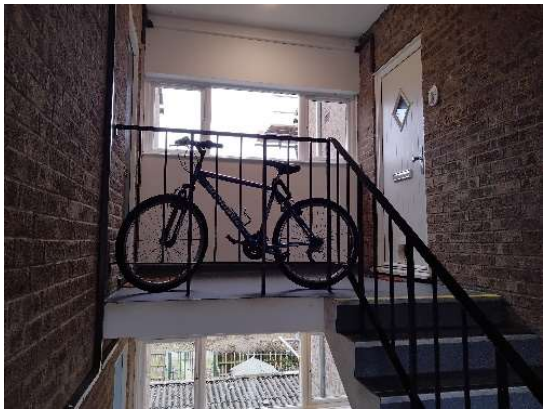
Smoke control / ventilation through window.	
Bicycle stored on means of escape.
