FIRE RISK ASSESSMENT REPORT
on behalf of Colchester Borough Homes

13-18 Camelia Court
Colchester
CO4 3PG

Date assessed: 21st March 2023

Project Number: 86953

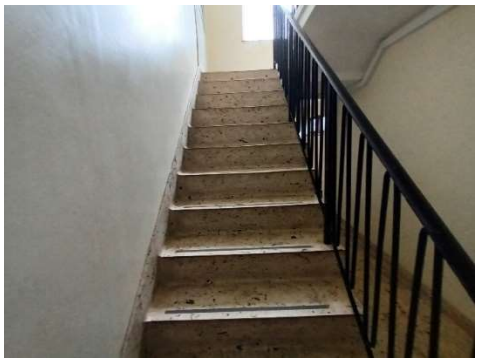
Internal wall linings and stairs, non-combustible.
