FIRE RISK ASSESSMENT REPORT
on behalf of Colchester Borough Homes

45-59 Cedar Avenue
Colchester
CO5 0NR

Date assessed: 22nd March 2023

Project Number: 87057

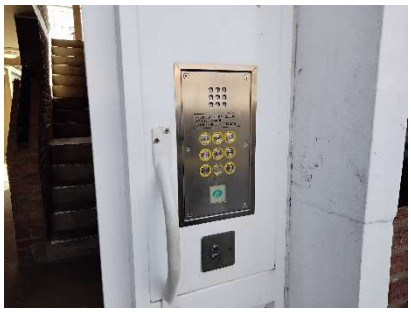
Door entry system.

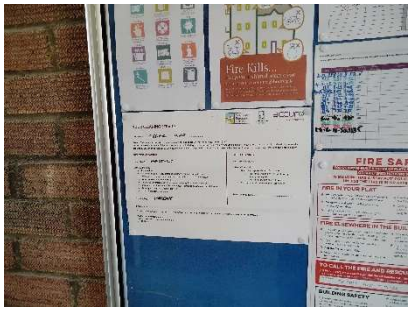
Housekeeping is of a good standard within the property and cleaning undertaken regularly, including rota displayed on notice board.

Cleaning Rota.

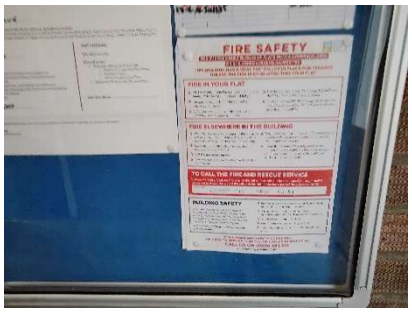
No ‘Keep Locked Shut’ signage on doors including entry doors.

Stay Put fire action notice.

No signage on entry door.

Hazard: Fire Safety Signs and Notices	Priority: Low
Issue Ref: ES/87057/006	
Significant Findings: No 'Keep Locked Shut' signage on doors including entry doors.	
Action Required: In line with Safety Signs and Signals Regulations 1996 - PART 3 Fire safety signs**,** 'Keep Locked Shut' sign to be fitted to entry door.	
Actioned by:	**Date of Action:**
Comments Following Action:
