FIRE RISK ASSESSMENT REPORT
on behalf of Colchester Borough Homes

17-20 Chant Court
Colchester
CO4 0JT

Date assessed: 6th March 2023

Project Number: 86924

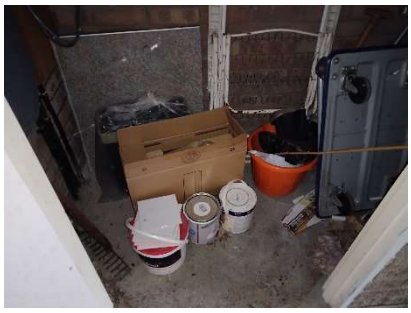
Hazard: Housekeeping	Priority: Medium
Issue Ref: ES/86924/002	
Significant Findings: There were combustible items noted within the electrical intake cupboard at the time of inspection.	
Action Required: Management should contact residents to advise that the electrical cupboard should be kept free from all combustible hazards. A programme of regular checks should be put in place to ensure that the common area is kept clear.	
Actioned by:	**Date of Action:**
Comments Following Action:

Cleaning rota	
Items in electric cupboard
