FIRE RISK ASSESSMENT REPORT
on behalf of Colchester Borough Homes

9 & 10 Chant Court
Colchester
CO4 0JT

Date assessed: 6th March 2023

Project Number: 86927

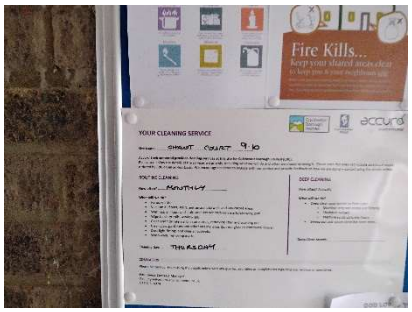
Cleaning rota

Housekeeping is of a good standard within the property and cleaning undertaken regularly, including rota displayed on notice board.
