FIRE RISK ASSESSMENT REPORT
on behalf of Colchester Borough Homes

22-28 Charles Pell Road
Colchester
CO4 3XT

Project Number: 86161

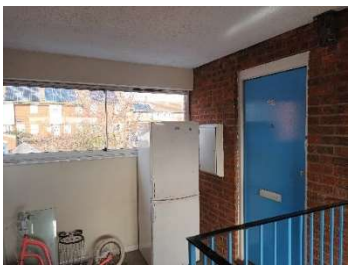
Hazard: Measures to Limit Fire Spread and Development	**Priority: Medium**
Issue Ref: ES/86161/008

Significant Findings: A number of residents front doors did not close fully, were ill fitting and residents reported seeing daylight between the door and frame. There were ill fitting smoke seals (assumed) present. There were no intumescent strips. There are rising butt hinges present. The letter boxes fitted did not appear to be fire rated which may compromise the integrity of this notional fire door. The Georgian glazing does not appear to be fire rated.	
Action Required: It is recommended that a fire door survey is completed, and any deficiencies noted are remedied. All Fire Door sets should be compliant/conform to BS 8214:2016 (Code of practice for Timber-based fire door assemblies) and BS 476-22:1987 or BS EN 1634-1:2014, maintained in a good state of repair, self-close fully, and be fitted with all necessary features (e.g., intumescent strips and cold smoke seals.)
