# FIRE RISK ASSESSMENT REPORT
# on behalf of Colchester Borough Homes

# 27-33 Chestnut Way
# Colchester
# CO5 0NX

**Date assessed: 13th December 2022**

**Project Number:86114**

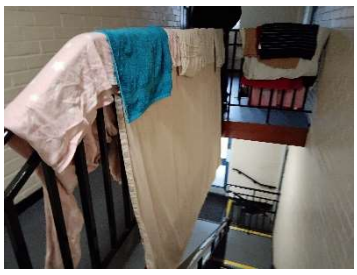
| **Hazard: Housekeeping** | **Priority: Medium** |
|---|---|
| ***Issue Ref:*** ES/86114/002 | |

| **Hazard: Housekeeping** | **Priority: Medium** |
|---|---|
| **Significant Findings:** There were combustible hazards noted within the common escape routes at the time of inspection. | |

| **Hazard: Housekeeping** | **Priority: Medium** |
|---|---|
| **Action Required:** Management should contact residents to advise that the common area/escape routes should be kept free from all combustibles and/or trip hazards. A programme of regular checks should be put in place to ensure that the common area is kept clear. | |

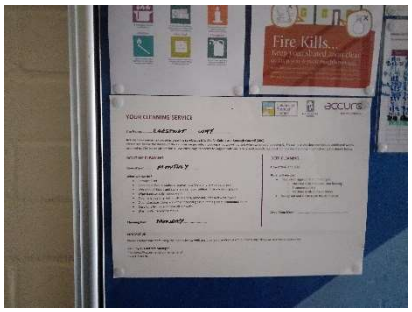
| Cleaning rota displayed on notice board. | |

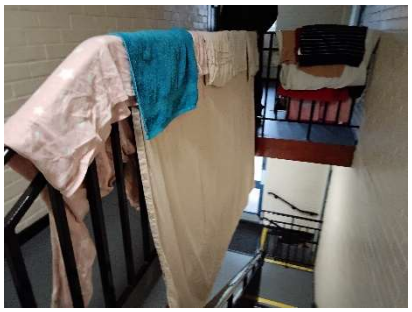
| There were combustible hazards noted within the common escape routes at the time of inspection. | |

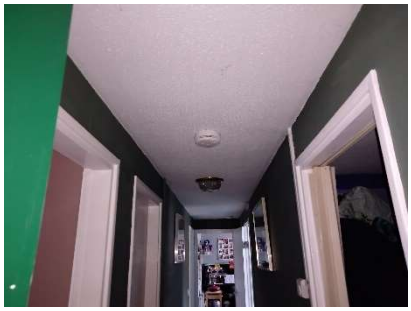
Entry was gained to flats 30 & 32; smoke detection has been installed within circulation areas of each flat.

| Smoke detection has been installed within circulation areas of each flat. | |
