FIRE RISK ASSESSMENT REPORT
on behalf of Colchester Borough Homes

42-48 Chestnut Way
Colchester
CO5 0NX

Date assessed: 13th December 2022

Project Number: 86117

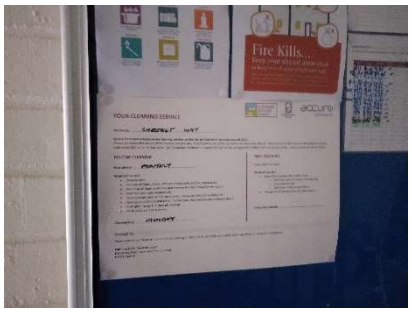
Cleaning rota displayed on notice board.

There were combustible hazards noted within the electrical intake cupboard at the time of inspection.

Hazard: Housekeeping	**Priority: Medium**
Issue Ref: ES/86117/002	
Significant Findings: There were combustible hazards noted within the electrical intake cupboard at the time of inspection.	
Action Required: Management should contact residents to advise that the common area/escape routes should be kept free from all combustibles and/or trip hazards. A programme of regular checks should be put in place to ensure that the common area is kept clear.	
Actioned by:	**Date of Action:**
Comments Following Action:

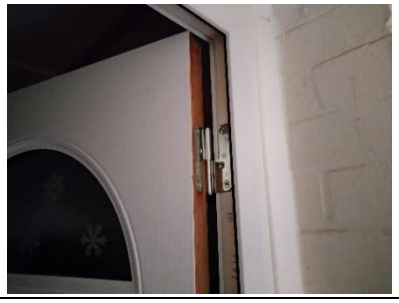
Flats 42 flat door sampled.

The assessor noted that there are no cold smoke seals or intumescent strips installed to the frame/door of the electrical riser cupboard.	
Meter cupboards are present within the communal area for each flat.

There was no access to the roof space above first floor flats.	
Flat 46 entrance door surround appears to be uPVC. This could compromise the fire resistance of the door.

Hazard: Measures to Limit Fire Spread and Development	Priority: Medium
Issue Ref: ES/86117/003	
Significant Findings: The assessor noted that there are no cold smoke seals or intumescent strips installed to the frame/door of the electrical riser cupboard.	
Action Required: Install cold smoke seals and intumescent strips to the top edges and both sides of the communal fire door/frame.	
Actioned by:	**Date of Action:**
Comments Following Action:

Hazard: Measures to Limit Fire Spread and Development	Priority: Medium
Issue Ref: ES/86117/006	
Significant Findings: Flat 46 entrance door surround appears to be uPVC. This could compromise the fire resistance of the door. uPVC entrance door surround may not be suitable to prevent fire/smoke spread and could hinder means of escape.	
Action Required: It will be necessary for door sets to be replaced under a risk-based programme.	
Actioned by:	**Date of Action:**
Comments Following Action:

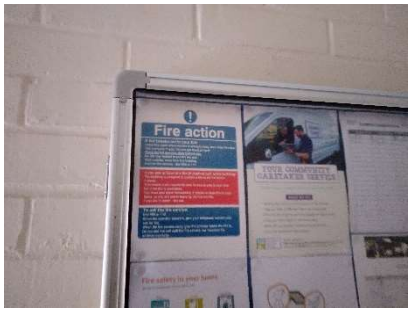
Keep Locked Shut and Danger Electricity signage on electrical intake cupboard.	
The current evacuation strategy is Stay Put as denoted by the fire action notices displayed in the common area.

Keep Locked Shut signage not on entry doors.

Hazard: Fire Safety Signs and Notices	Priority: Low
Issue Ref: ES/86117/008	
Significant Findings: Keep Locked Shut signage not on entry doors.	
Action Required: Keep Locked Shut signage to be installed on external of electrical intake cupboard.	
Actioned by:	**Date of Action:**
Comments Following Action:
