FIRE RISK ASSESSMENT REPORT
on behalf of Colchester Borough Homes

19-24 Christine Chase
Colchester
CO3 4DP

Date assessed: 10th October 2022

Project Number: 85714

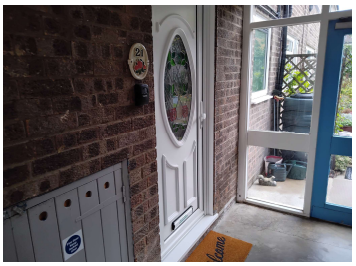
Hazard: Measures to Limit Fire Spread and Development	**Priority: Medium**
Issue Ref: ES/85714/006	
Significant Findings: Flat 21 entrance door appears to be uPVC. This could compromise the fire resistance of the door. uPVC entrance doors are not suitable to prevent fire/smoke spread and could hinder means of escape.

Action Required: It will be necessary for door sets to be replaced under a risk-based programme.

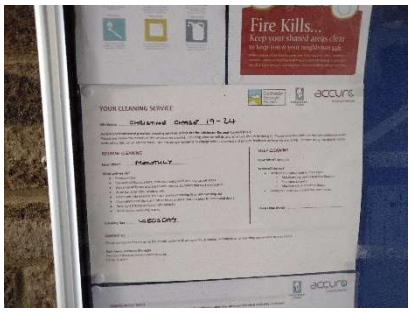
Housekeeping sign off sheet within common area
