FIRE RISK ASSESSMENT REPORT
on behalf of Colchester Borough Homes

7-12 Christine Chase
Colchester
CO3 4DP

Date assessed: 10th October 2022

Project Number: 85715

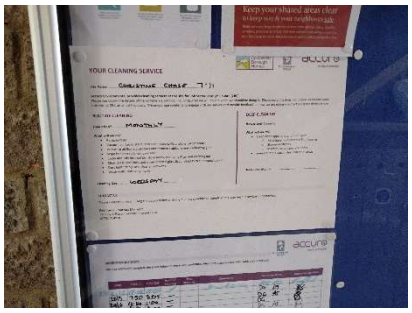
Housekeeping sign off sheet within common area

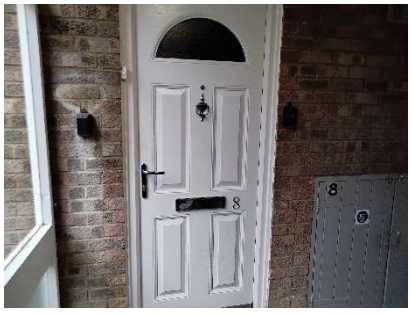
The assessor noted that there are no cold smoke seals or intumescent strips installed to the frame/door of the electrical riser cupboard	
Compartmentation issues noted at the time of inspection include – Walls on ground and first floor have vent grills leading to flats	
. Flat entrance doors/frames 7, 8, 9 & 10 are replacement composite fire doors (N.B. - From limited visual inspection as no flats were inspected; certification not seen; adequacy of installation not confirmed)

Flat entrance door/frame 11 & 12 are original timber doors (N.B. - From limited visual inspection as no flats were inspected; certification not seen; adequacy of installation not confirmed

Hazard: Measures to Limit Fire Spread and Development	Priority: Medium
Issue Ref: ES/85715/003	
Significant Findings: The assessor noted that there are no cold smoke seals or intumescent strips installed to the frame/door of the electrical riser cupboard.	
Action Required: Install cold smoke seals and intumescent strips to the top edges and both sides of the communal fire door/frame.	
Actioned by:	**Date of Action:**
Comments Following Action:

Issue Ref: ES/85715/005	
Significant Findings: Flat entrance doors/frames 7, 8, 9 & 10 are replacement composite fire doors (N.B. - From limited visual inspection as no flats were inspected; certification not seen; adequacy of installation not confirmed).	
Action Required: Inspection should be carried out to confirm the adequacy of composite door set installations including the fixings and firestopping between the frame and the wall.	
Actioned by:	**Date of Action:**
Comments Following Action:

Hazard: Measures to Limit Fire Spread and Development	**Priority: Medium**
Issue Ref: ES/85715/006	
Significant Findings: Flat entrance door/frames 11 & 12 are original timber doors (N.B. - From limited visual inspection as no flats were inspected; certification not seen; adequacy of installation not confirmed).	
Action Required: Inspection should be carried out to confirm the adequacy of door set installations including the fixings and firestopping between the frame and the wall.	
Actioned by:	**Date of Action:**
Comments Following Action:
