FIRE RISK ASSESSMENT REPORT
on behalf of Colchester Borough Homes

31 & 33 Conifer Close
Colchester
CO4 3PF

Date assessed: 30th March 2023

Project Number: 87014

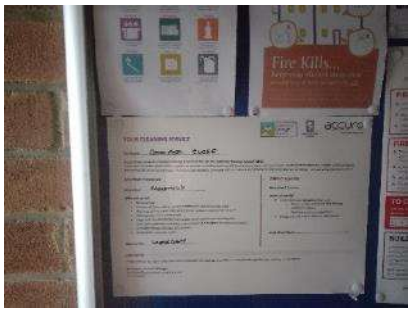
Housekeeping is of a good standard within the property and cleaning undertaken regularly, including rota displayed on notice board.

Wheelie bins	
Cleaning rota
