FIRE RISK ASSESSMENT REPORT
on behalf of Colchester Borough Homes

1-6 Constable Court
Colchester
CO2 9EE

Date assessed: 24th October 2022

Project Number: 85739

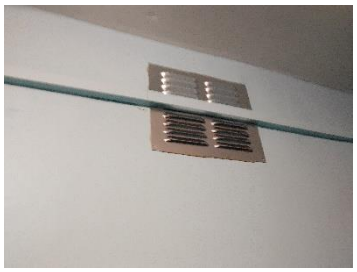
Hazard: Measures to Limit Fire Spread and Development	**Priority: Medium**
Issue Ref: ES/85739/005

Significant Findings: Compartmentation issues noted at the time of inspection include - Personal storage cupboards located on ground floor have vents above the doors.	
Action Required: To prevent fire/smoke spread, the vents above all cupboard doors should be fire stopped by a competent contractor using suitable fire resisting materials that achieve a minimum of thirty minutes of fire resistance.	
Actioned by:	**Date of Action:**
Comments Following Action:
