# FIRE RISK ASSESSMENT REPORT
# on behalf of Colchester Borough Homes

# 7-10 Dammant Court
# Colchester
# CO4 3SA

**Date assessed: 21st March 2023**

**Project Number: 86960**

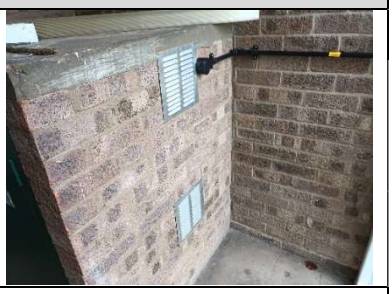
| Hazard: Measures to Limit Fire Spread and Development | Priority: Medium |
|---|---|
| ***Issue Ref:*** ES/86960/007 | |

| Hazard: Measures to Limit Fire Spread and Development | Priority: Medium |
|---|---|
| **Significant Findings:** The Consultant advises that two alloy vents are fitted to the bin store brick wall. This will allow smoke onto the means of escape in the event of a fire. | |

| Hazard: Measures to Limit Fire Spread and Development | Priority: Medium |
|---|---|
| **Action Required:** It is recommended that these vents are removed, and the wall made good. | |
