FIRE RISK ASSESSMENT REPORT
on behalf of Colchester Borough Homes

1-4 Dansie Court
Colchester
CO4 0EA

Date assessed: 21st March 2023

Project Number: 86991

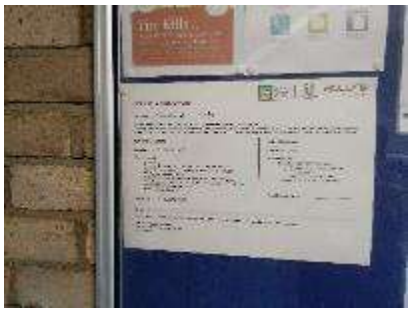
There were combustible items and trip hazards in the escape routes.

Refuse cupboards	
Cleaning rota

Items in common area

Hazard: Housekeeping	**Priority: Low**
Issue Ref: ES/86991/002	
Significant Findings: There were combustible items and trip hazards in the escape routes.	
Action Required: Management should contact residents to advise that the common area/escape routes should be kept free from all combustibles and/or trip hazards. A programme of regular checks should be put in place to ensure that the common area is kept clear.	
Actioned by:	**Date of Action:**
Comments Following Action:
