FIRE RISK ASSESSMENT REPORT
on behalf of Colchester Borough Homes

7-12 Dedham Court
Colchester
CO2 8SN

Date assessed: 7th December 2022

Project Number: 86050

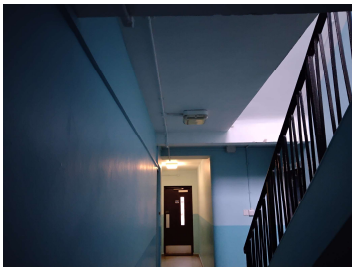
Hazard: Means of Escape	Priority: Medium
Issue Ref: ES/86050/005

Significant Findings: General lighting in common areas on ground & first are not working to their full potential and causes reduced lighting on stairwell and ground floor during hours of darkness.	
Action Required: Lighting within the common areas to be regularly inspected and any repairs should be completed as soon as possible.	
Actioned by:	**Date of Action:**
Comments Following Action:

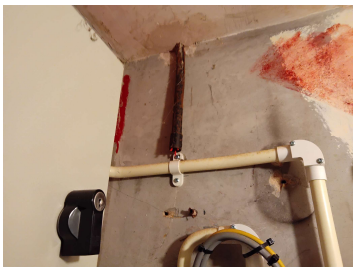
Hazard: Measures to Limit Fire Spread and Development	Priority: Medium
Issue Ref: ES/86050/006

Significant Findings: It was noted that the electrical intake cupboard may not be fully compartmented due to old cable/pipework protruding from ceiling of cupboard.	
Action Required: To prevent fire/smoke spread, the cables above all cupboard doors should be fire stopped by a competent contractor using suitable fire resisting materials that achieve a minimum of thirty minutes of fire resistance.	
Actioned by:	**Date of Action:**
Comments Following Action:

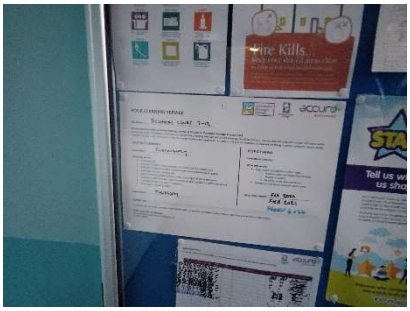
Housekeeping is of a good standard within the property and cleaning undertaken regularly, including rota displayed on notice board
