FIRE RISK ASSESSMENT REPORT
on behalf of Colchester Borough Homes

3-18 Docker Court
Colchester
CO2 8SP

Date assessed: 23rd March 2023

Project Number: 87070

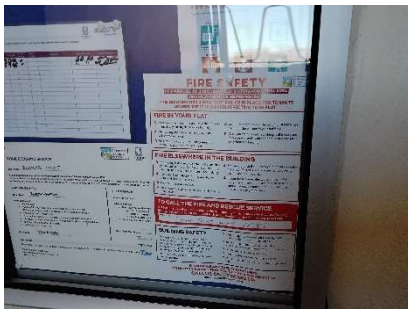
Stay Put fire action notice
