FIRE RISK ASSESSMENT REPORT
on behalf of Colchester Borough Homes

11-16 Duffield Drive
Colchester
CO4 3YQ

Date assessed: 7th March 2023

Project Number: 86901

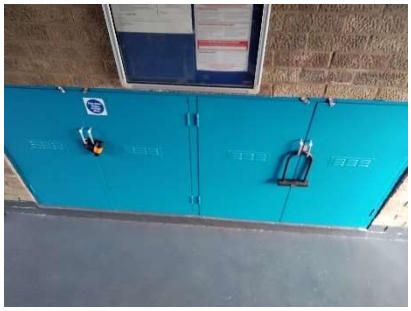
Refuse area.

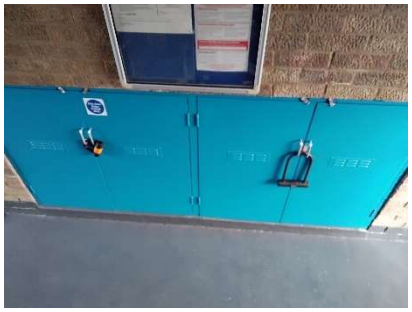
Refuse area.

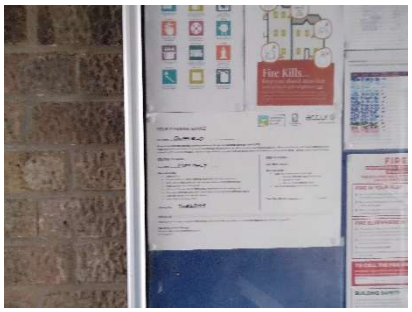
Cleaning Rota.
