FIRE RISK ASSESSMENT REPORT
on behalf of Colchester Borough Homes

7-10 Duffield Drive
Colchester
CO4 3YQ

Date assessed: 7th March 2023

Project Number: 86905

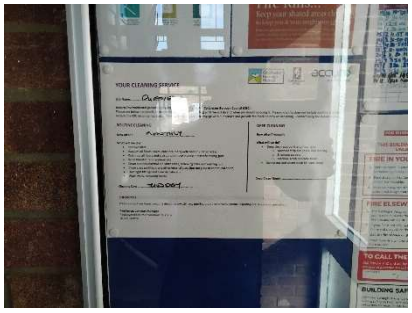
Housekeeping is of a good standard within the property and cleaning undertaken regularly, including rota displayed on notice board.

Refuse area.	
Cleaning Rota.
