FIRE RISK ASSESSMENT REPORT
on behalf of Colchester Borough Homes

50-52 Erle Havard Road
West Bergholt
Colchester
CO6 3LH

Date assessed: 6th March 2023

Project Number: 86143

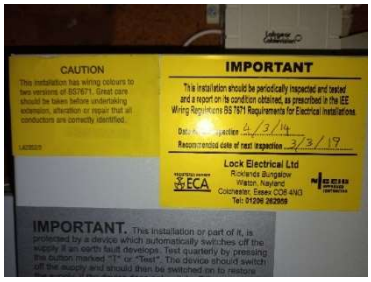
Hazard: Electrical Sources of Ignition	**Priority: Medium**
Issue Ref: ES/86143/003

Significant Findings: Evidence suggests that the last electrical fixed wiring test for the common areas has not been completed since 04/03/2014. Faulty electrics can be a source of ignition for fires.	
Action Required: It is recommended that electrical fixed wiring test is completed by a competent person if not already done so and records made available for verification. No report was witnessed. The Responsible Person should ensure any remedial actions are completed and the test is certified satisfactory

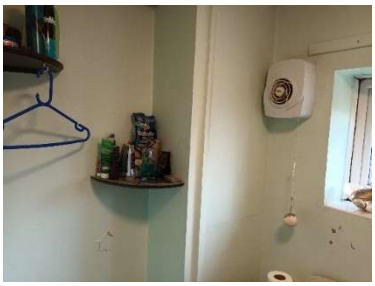
Hazard: Measures to Limit Fire Spread and Development	Priority: Advisory
Issue Ref: ES/86143/005

Significant Findings: The Consultant advises that there appeared to be service riser pipes boxed in. The Consultant was unable to confirm if these pipes had been adequately fire stopped to prevent the spread of fire, smoke, and products of combustion in the event of a fire.	
Action Required: It is recommended that a competent person completes a fire stopping survey to ascertain if fire adequate fire stopping is in place in all flats and the outcome recorded. If not, remedial work should be completed with records retained and produced on request.

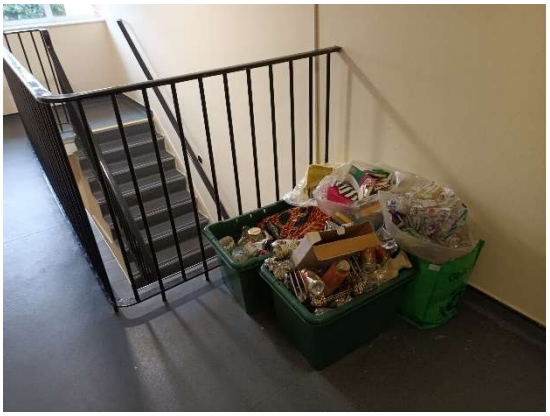
On the means of escape.

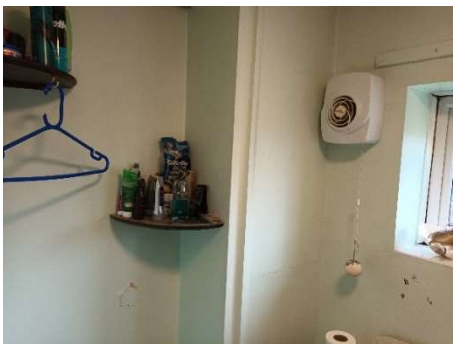
Service riser boxed in,
