FIRE RISK ASSESSMENT REPORT
on behalf of Colchester Borough Homes

11-14 Fairbrother Court
Colchester
CO4 3SD

Project Number: 86964

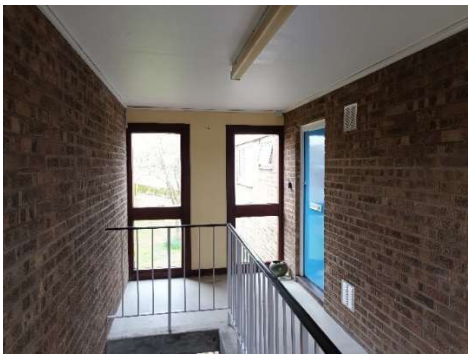
Internal wall linings and first floor landing area, non-combustible.
