FIRE RISK ASSESSMENT REPORT
on behalf of Colchester Borough Homes

2-8 Faulds Walk
Colchester
CO2 8RL

Date assessed: 18th November 2022

Project Number: 86051

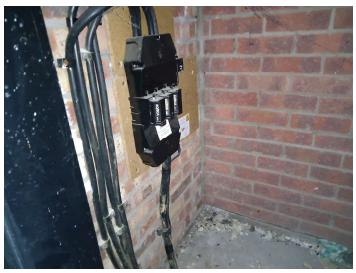
Hazard: Electrical Sources of Ignition	**Priority: Medium**
Issue Ref: ES/86051/001

Significant Findings: The assessor did not see any documented evidence that suggested that fixed wire testing has been carried out within the last five years.	
Action Required: Management to confirm fixed wiring has been tested within the last 5 years, alternatively, confirm there is separate landlord supply directly to own flats.

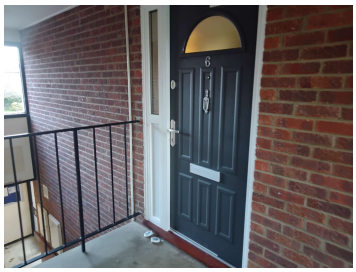
Hazard: Measures to Limit Fire Spread and Development	Priority: Low
Issue Ref: ES/86051/004

Significant Findings: Flat entrance doors/frames are replacement composite fire doors (N.B. - From limited visual inspection as no flats were inspected; certification not seen; adequacy of installation not confirmed).	
Action Required: As flat entrances have been fitted with composite door sets, these should have test evidence demonstrating they meet the performance requirement in Building Regulations guidance for fire resistance and smoke control from both sides. Management should confirm that suitable fire door test certificates are held and that these relate to the doors fitted.	
Actioned by:	**Date of Action:**
Comments Following Action:

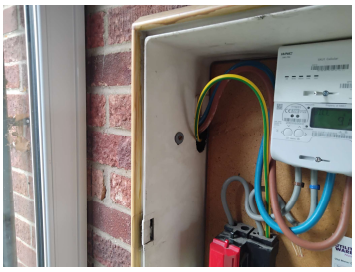
Hazard: Measures to Limit Fire Spread and Development	Priority: Medium
Issue Ref: ES/86051/007

Significant Findings: Meter cupboards are present within the communal area for each flat. Upon inspection of the meter cupboards the assessor found that cables have not been fire stopped as they enter into the cavity. A fire in these cupboards could spread into the cavity.	
Action Required: The meter cupboards should be fire stopped by a competent contractor using suitable fire resisting materials that conform to BS 476 and achieve a minimum of thirty minutes of fire resistance.	
Actioned by:	**Date of Action:**
Comments Following Action:
