FIRE RISK ASSESSMENT REPORT
on behalf of Colchester Borough Homes

1-6 Field Court
Colchester
CO4 3LL

Date assessed: 13th March 2023

Project Number: 86928

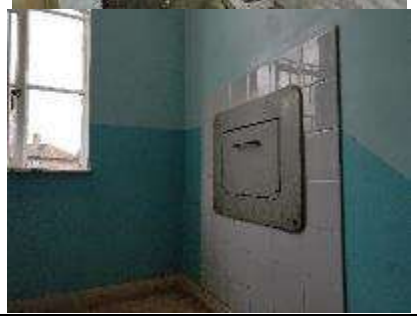
Access control on entry doors	
Waste chute cupboard

Refuse chutes and access hatches were seen directly opening onto landings/stairs, so providing the potential for the spread of fire and smoke to the common escape routes.

Hazard: Arson	**Priority: Low**
Issue Ref: ES/86928/001	
Significant Findings: Refuse chutes and access hatches were seen directly opening onto landings/stairs, so providing the potential for the spread of fire and smoke to the common escape routes.	
Action Required: LGA - 'Fire safety in purpose-built blocks of flats' – 2012 Section 65 It is recommended that refuse and chute rooms should be provided with an automatic fire-resisting shutter to be fitted at the base of the refuse chute to restrict the spread of fire and smoke from a fire in the bin room. The shutter should, as a minimum, be operated on a fixed temperature fusible link.	
Actioned by:	**Date of Action:**
Comments Following Action:
