FIRE RISK ASSESSMENT REPORT
on behalf of Colchester Borough Homes

1-6 Fuchsia Court
Colchester
CO4 3PH

Project Number: 86609

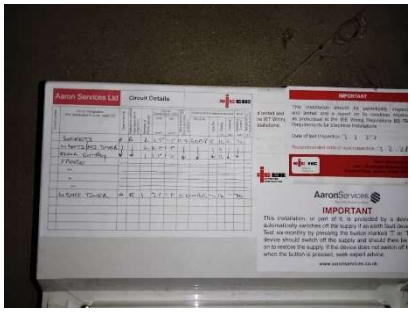
A system testing label dated 03/02/2023 was fitted to the Main Circuit Board. This means the system is due for retesting by 02/2028.

System testing label
