FIRE RISK ASSESSMENT REPORT
on behalf of Colchester Borough Homes

25-32 Greenfields House
Birch Green
Colchester
CO2 0NJ

Date assessed: 31st March 2023

Project Number: 87074

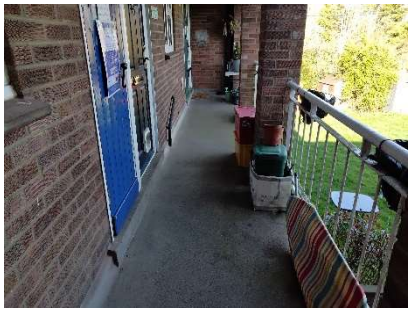
Example flat door

Flat entrance doors/frames appear to be replacement composite fire doors (N.B. - From limited visual inspection of flat, however, certification not seen; adequacy of installation not confirmed).

It is understood that Colchester Borough Homes Property Services are carrying out a programme on Flat entrance fire doors which entails, surveying fire doors for their effectiveness at preventing the spread of fire/smoke to or from common areas, and any that are deemed unsatisfactory will be replaced/repaired as part of a fire door remedial programme. Therefore, refer to the fire door survey and remedial programme for information relating to fire door compliance within the premises.

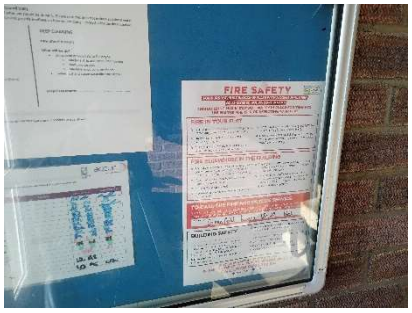
Stay Put fire action notice

There is also “No Smoking” signage in common area.
