FIRE RISK ASSESSMENT REPORT
on behalf of Colchester Borough Homes

13-19 Gurdon Road
Colchester
CO2 7PB

Date assessed: 14th November 2022

Project Number: 86082

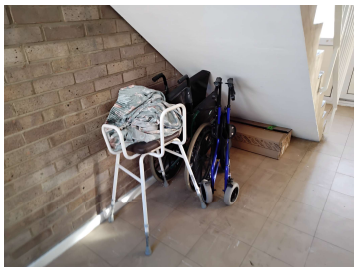
Hazard: Housekeeping	Priority: Low
Issue Ref: ES/86082/006

Significant Findings: There were combustible items noted within the common escape routes at the time of inspection.	
Action Required: Management should contact residents to advise that the common area/escape routes should be kept free from all combustible materials. A programme of regular checks should be put in place to ensure that the common area is kept clear.	
Actioned by:	**Date of Action:**
Comments Following Action:

There were combustible items noted within the common escape routes at the time of inspection
